## Observations from the EEFIT-TDMRC Mission to Sulawesi, Indonesia to Investigate the 28th September 2018 Central Sulawesi Earthquake

Lagesse, Richard; Rossetto, Tiziana; Raby, Alison; Brennan, Andrew; Robertson, David; Adhikari, Rohit Kumar

*Published in:*  
SECED 2019 Proceedings

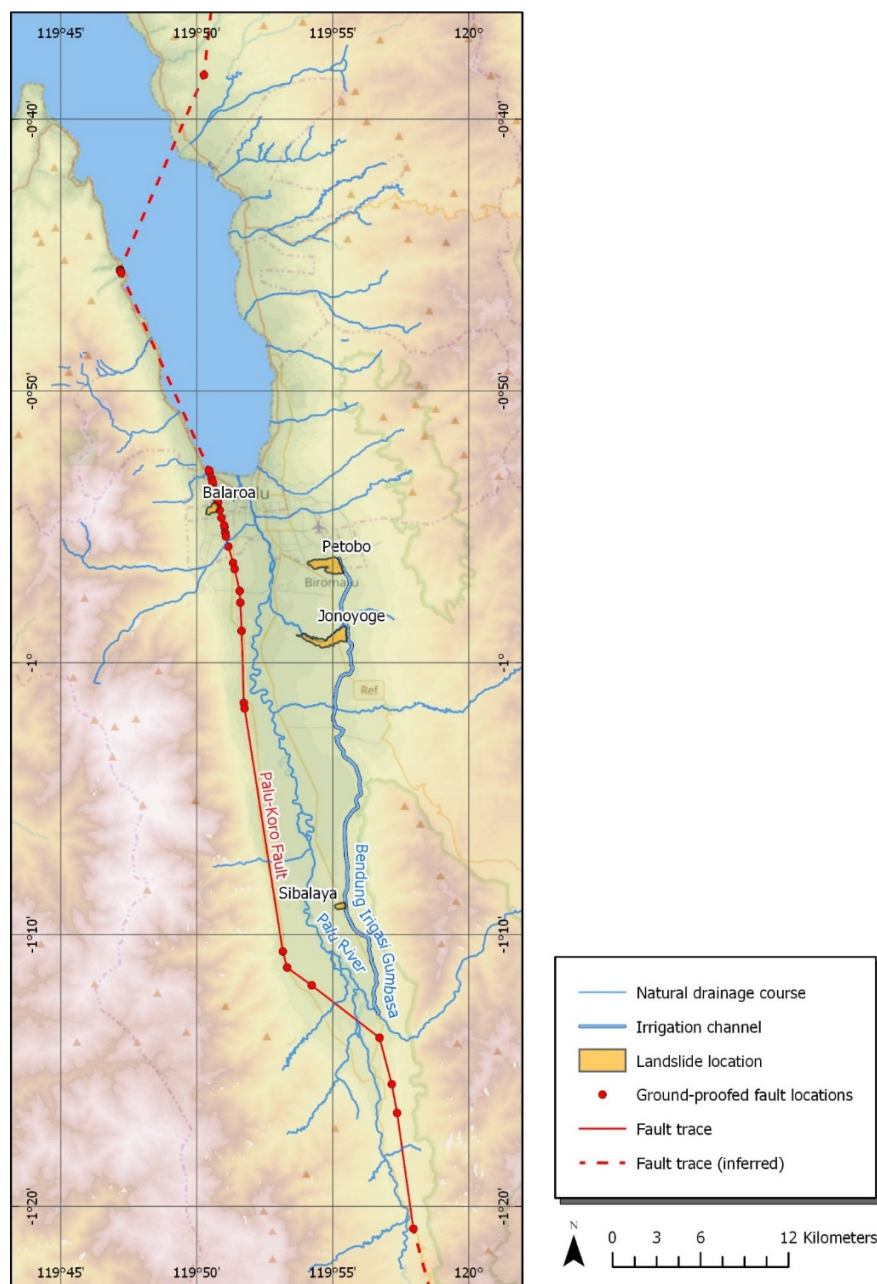
Part of the mission was focussed on ground-proofing the fault rupture (Figure 1) and surface rupture of the fault was observed in the field with evidence of displacement identified at the Palu city bay-front area and at the far southern end of the Palu valley. Other instances of surface fault rupture were identified on the western side of the Gulf of Palu at Tasiburi as well as on the eastern side of the bay near Dalaka. However, the interconnectivity of these ruptures with the surface rupture in the Palu valley area is inferred, particularly the undersea component.

Figure 1. Overview of Palu valley showing the Palu-Koro Fault, major landslides, Bendung Irigasi Gumbasa irrigation channel and the major natural drainage courses.
